Combis

in hot water

Tarquin Purdie from Powerflush discusses resolving hot water problems associated with combination boilers.

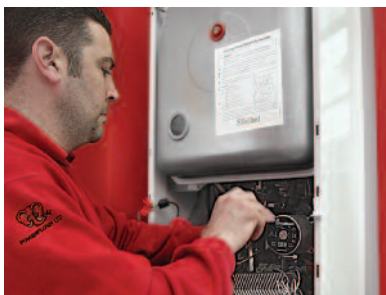
Photo 1. Removing pump face.

There are some boiler designs where it is not practical to remove the complete pump assembly, and a pump adaptor which replaces the pump head/motor and attaches to the pump manifold can be used. These adaptors do not fit all circulator pump designs and care is required when attaching to some plastic manifolds to avoid damage.

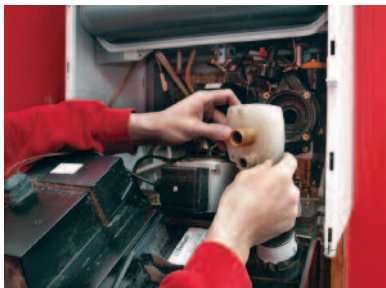
Photo 2. Attaching pump adaptor.

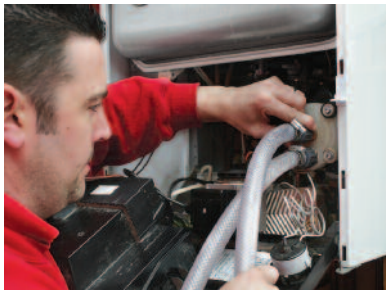
Photo 3. Attaching power flushing hoses.

To thoroughly clean pipes and radiators when power flushing, it is important to connect at the pump rather than at a radiator, in order to have proper control of flow through the system. With combination boilers a second reason to connect at the pump is so that when the system calls for water and the diverter valve moves to the hot water position, the power flush machine is still part of the circuit (a connection at a radiator or connections 'teed' into flow and return pipework would not be).

When making power flushing connections inside the casing of a combination boiler, as well as adopting safe isolation practices, care is required to avoid water leaks causing damage to electrical components.

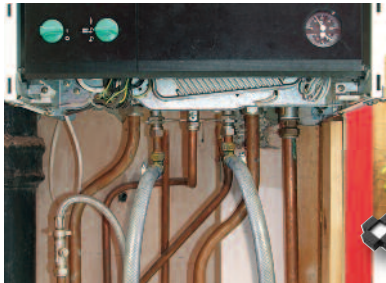
Photo 4. Combi boiler being descaled.

Descal the domestic water side of the plate heat exchanger, possibly followed by replacement if not completely cleared. Subsequently fit lime scale polyphosphate water conditioner giving the customer guidance for changing cartridges when necessary.
