Combis

in hot water

Tarquin Purdie from Powerflush discusses resolving hot water problems associated with combination boilers.

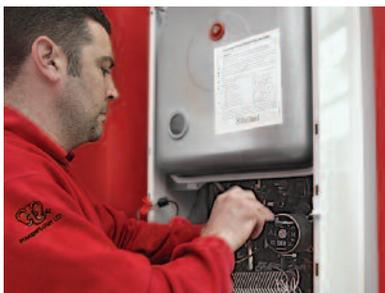
Photo 1. Removing pump face.

There are some boiler designs where it is not practical to remove the complete pump assembly, and a pump adaptor which replaces the pump head/motor and attaches to the pump manifold can be used. These adaptors do not fit all circulator pump designs and care is required when attaching to some plastic manifolds to avoid damage.

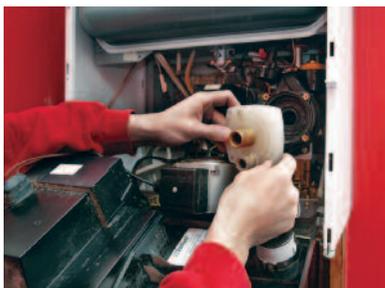
Photo 2. Attaching pump adaptor.

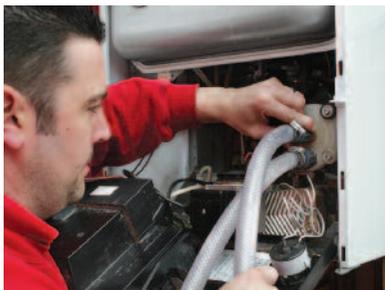
Photo 3. Attaching power flushing hoses.

To thoroughly clean pipes and radiators when power flushing, it is important to connect at the pump rather than at a radiator, in order to have proper control of flow through the system. With combination boilers a second reason to connect at the pump is so that when the system calls for water and the diverter valve moves to the hot water position, the power flush machine is still part of the circuit (a connection at a radiator or connections 'teed' into flow and return pipework would not be).

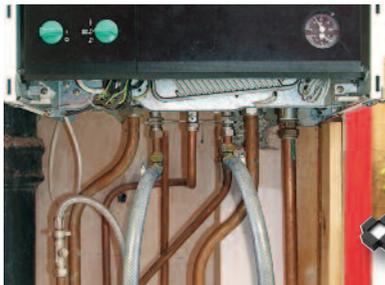
Photo 4. Combi boiler being descaled.

Descal the domestic water side of the plate heat exchanger, possibly followed by replacement if not completely cleared. Subsequently fit lime scale polyphosphate water conditioner giving the customer guidance for changing cartridges when necessary.
